Kingsgate

Chatree Gold Mine Overhaul Update

Plant #1 Overhaul Project

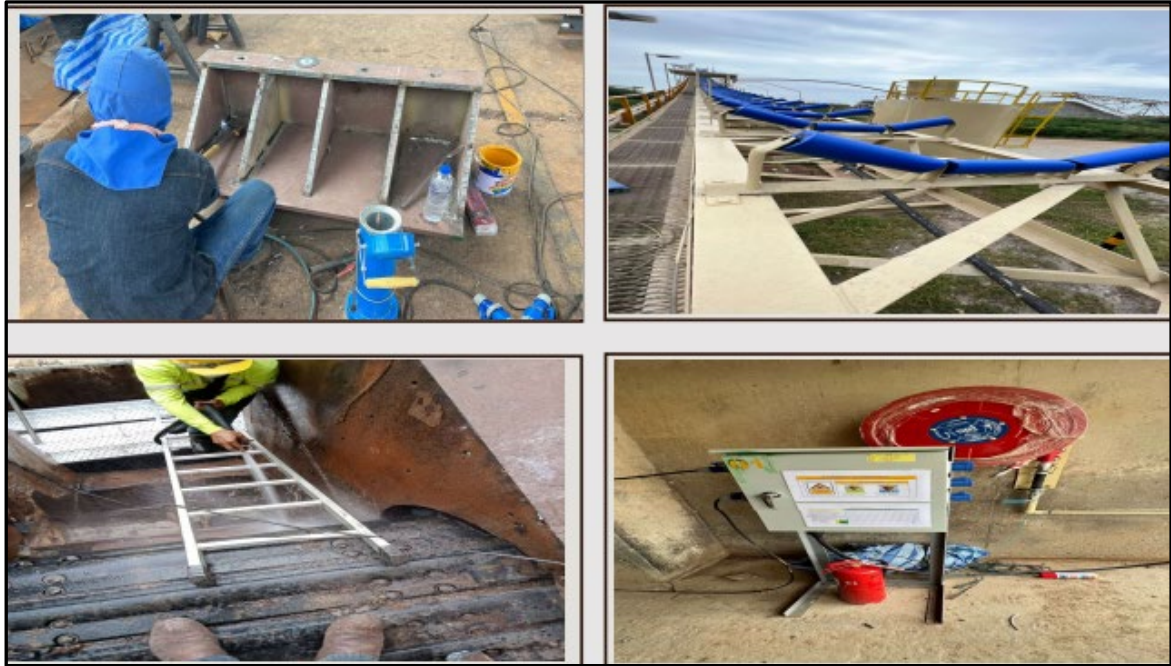
Crushing Circuit overhaul above (left to right): CV001 repairs, ROM bin concreting, raw water pump replacement and piping, fabricating and welding the grizzly feed chute, and below (left to right): fabricating and welding the grizzly feed chute, replacing carry roller #01CV01, fabricating and welding the grizzly feed chute, electrical board safety information.

1. Concreting the ROM bin wall;
2. Painting and repairing the raw water pipes;
3. Connecting a power source to the pump motor;
4. Sandblasting the apron feeder;
5. The installation of a temporary power panel;
6. Removing the chute and liner;
7. Replacing carry roller #01CV01; and
8. Fabricating and welding the grizzly feed chute.

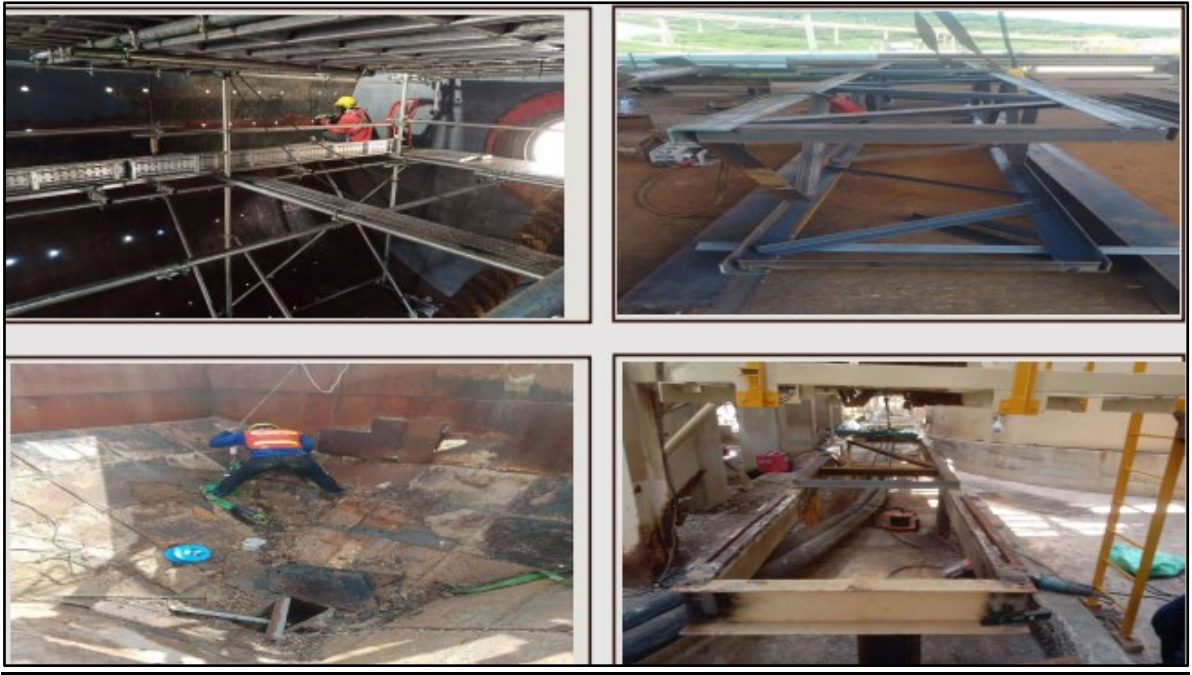
Grinding Circuit repairs above (left to right): SAG mill rubber lining removal, structure frame for conveyor CV09, repairs to conveyor hopper and conveyor frame repairs CV04.

1. Removing and replacing the rubber liner in the ball mill;
2. Installing scaffolding in the SAG mill;
3. Repairing conveyors #03CV04 and #03CV05;
4. Fabricating chutes and repairing hoppers;
5. Fabricating conveyor #03CV09;
6. Overhauling the motors of #04TK502, #04PU04, #04PU05
7. Installing scaffolding inside tank #04TK499;
8. Installing motors #04PU73, #04PU05;
9. Installing a temporary power panel;
10. Disconnecting the electrical control panel on the Cyclone;
11. Painting hoppers, handrails, and stairs; and
12. Removing the Cyclone and overhead crane.

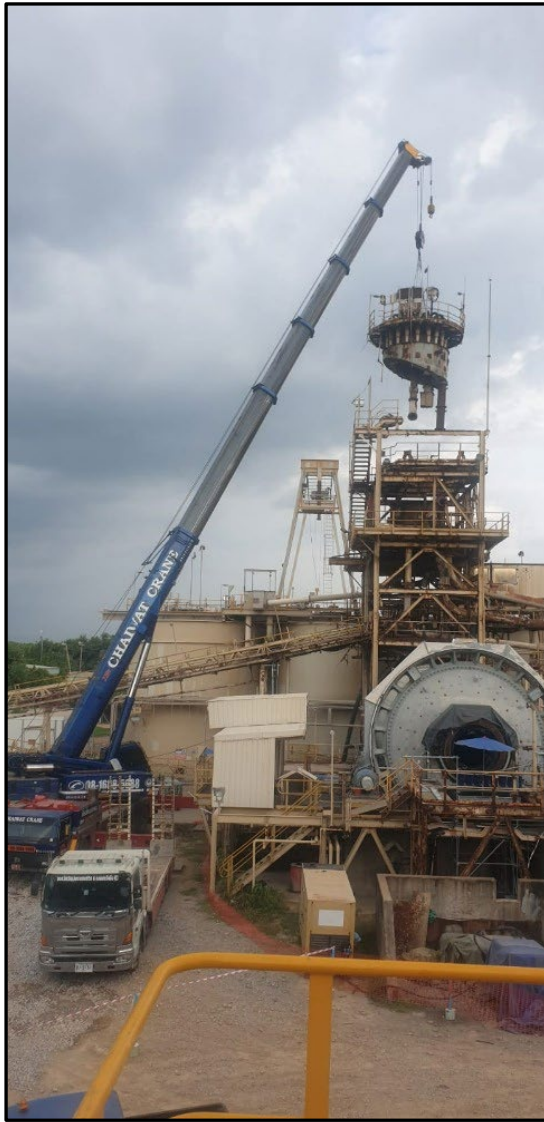
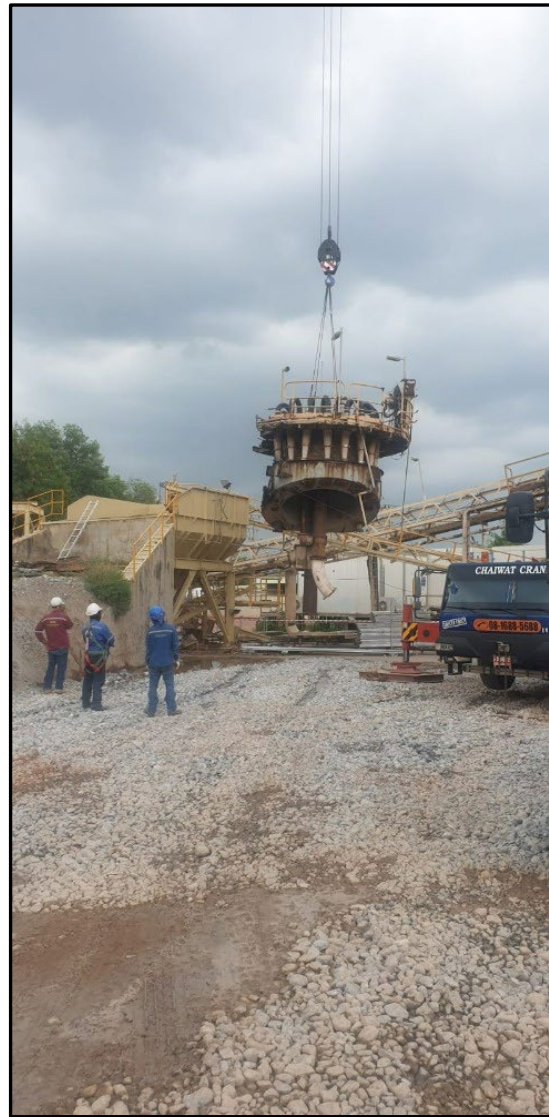
Removal of the Cyclone separator for replacement from Plant #1.

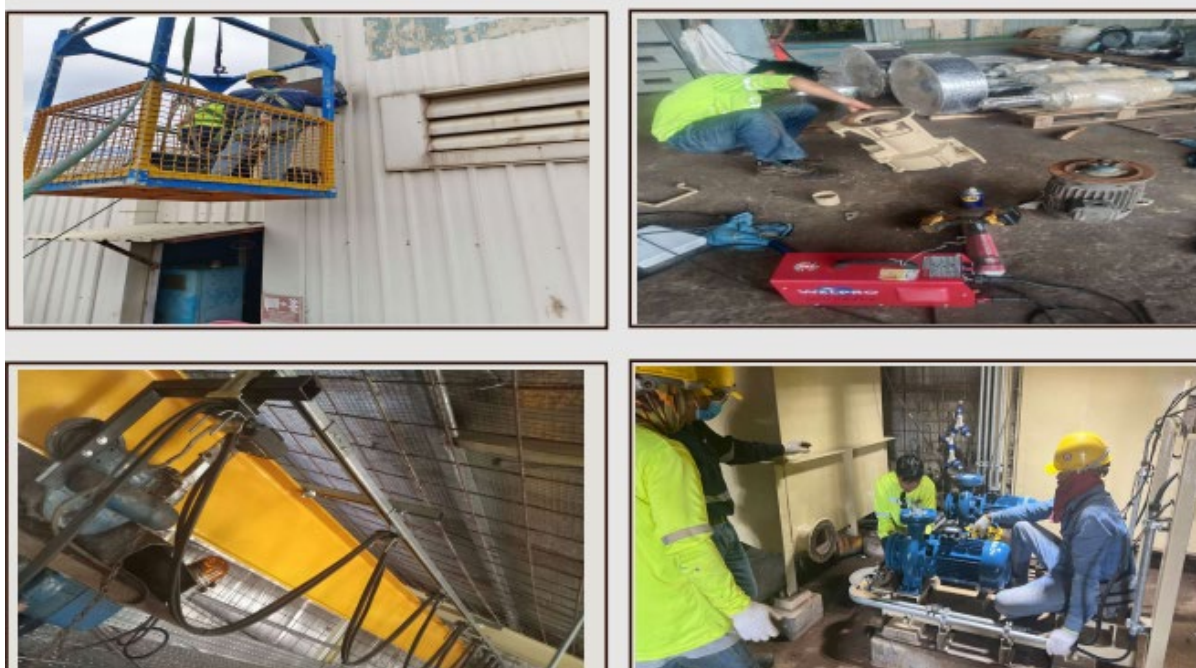
Gold Room repairs (left to right): light replacement, overhaul of the diagram pump, new gantry crane and new gold circuit pump installation.

1. Fabricating the raw water pipes;
2. Painting steel columns;
3. Replacing the cable tray and connected the lighting;
4. Replacing lighting and installed cable panel;
5. Overhauling overhead crane #06HT05;
6. Overhauling pump #06PU14; and
7. Installing pump #06PU58 A, and B.
